## LAND CORNER RECORD

| Index: V-17 | Corner: Common Corner between Sections 26, 27, 34 and 35 | State of Indiana - Hoosier National Forest |
| Section: 27 | Township: 7N Range: 1E P.M.: 2nd | County: Monroe |

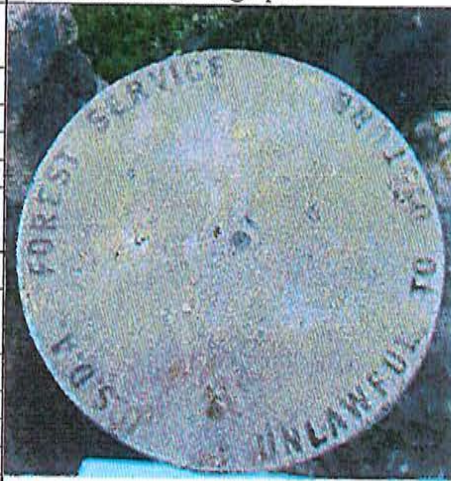
The record monument was found washed out and recovered downstream. The monument was reset by its prior 1982 Land Corner Record and maintained by remarking three existing bearing trees and establishing one new bearing tree. Three existing bearing trees were recovered from a Monument Record by Kevin Enright, dated 4/7/2009, referencing the 1982 witness post (monument was washed out prior to 2009).

| Reference Objects: | Object or Tree Species: | Diameter: | Bearing: | Distance: |
|---|---|---|---|---|
| Monument Found or Set: | A 3" aluminum monument stamped "U.S.D.A. FOREST SERVICE UNLAWFUL TO DISTURB" was reset 1.2' above grade (hit rock) using previous bearing trees. | | | |

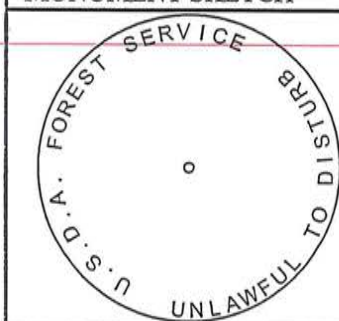
## MONUMENT SKETCH

Monument is a 3" aluminum monument stamped "U.S.D.A. FOREST SERVICE UNLAWFUL TO DISTURB" which was reset 1.2' above grade (hit rock) using previous bearing trees stump holes from 1982 Land Corner Record, a carsonite post is located 4.2' S70°W of the monument, located 2' west of a meandering drainage, in an area that had been washed out, +/- 20' north of a steep bank, a mound area to the east is approximately 4' higher than the monument, a Pine stand is to the east on top of a ridge top heading back to St. Rd. 446, a rock cairn was placed at the base of the monument.

Four bearing trees were marked with a blaze, scribed B.T., bearing tree sign and mag nail.

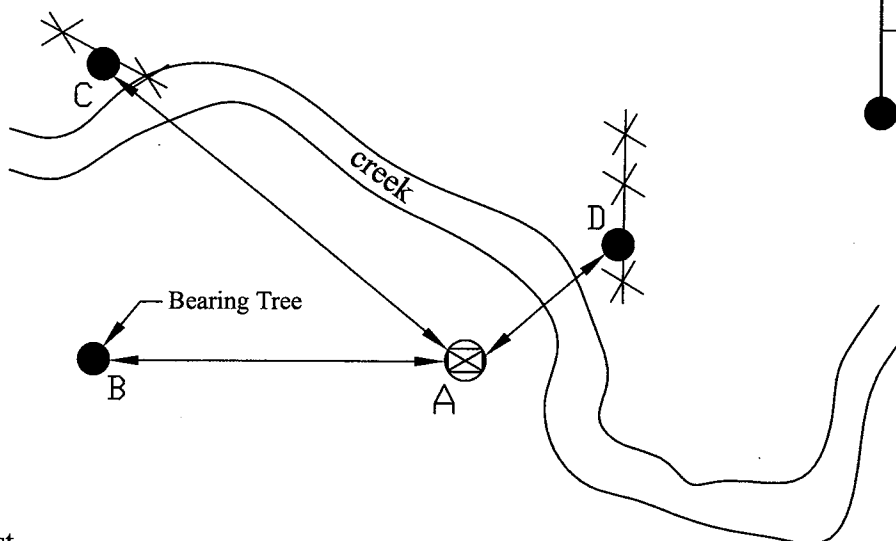
RECOVERY TIE DRAWING  
Field Book 41 Page No. 74

**Monument Description & Remarks:** Metal Fence Post with sign, "LAND SURVEY MONUMENT". Survey Sign 3ft at pt. A

- A - Metal Fence Post
- B - N 78° W 24.70' to MAG  
nail in 9" Sugar Maple
- C - N 51° W 43.10' to MAG  
nail in 17" Sugar Maple
- D - N 18° E 21.16' to MAG  
nail in 32" White Oak
